Identifying unstable rock blocks by measuring micro-tremors and vibration on cliffs

Landslide Research Team, Erosion and Sediment Control Research Group, Public Works Research Institute, Japan

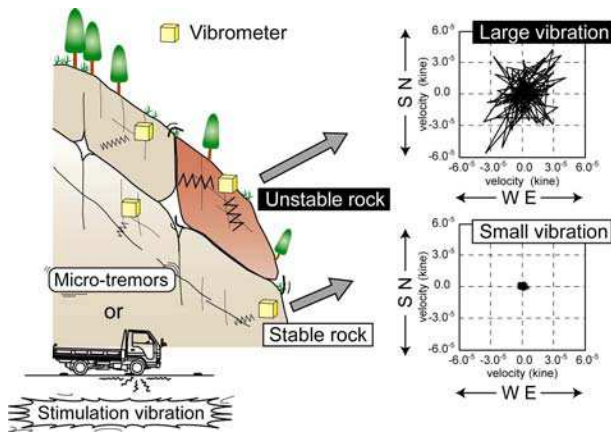
Fig. 1. Image of this measuring method

Hence we carried out a field test to develop a method of simply and precisely identifying unstable rock blocks by measuring vibrations of a rock cliff. This method of identifying unstable rock blocks is based on the idea that in contrast to stable rock in which surrounding cracks adhere closely and are integrated with the foundation, in unstable rock blocks, the cracks have opened and deteriorated, causing separation from the foundation, with the result that unstable rock vibrates more than stable rock (Fig. 1).

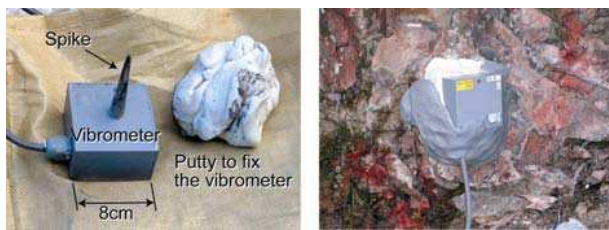
Fig. 2. Vibrometer shape and its installation.

search Team, Erosion and Sediment Research Group, 2007). At this time, the amplitude of vibrations applied to the cliff is not constant, so in principle, one measurement point is set on a known stable baserock to measure its vibrations. The vibrometers that are used can measure vibrations in three dimensions, and their size is approximately $8 \times 8 \times 4$ cm. Each vibrometer is equipped with an approximately 8cm long spike and is installed by drilling a hole in the rock, inserting the spike in the hole, then fixing it in place with putty (Fig. 2). They are installed by rock climbers (Fig. 3).

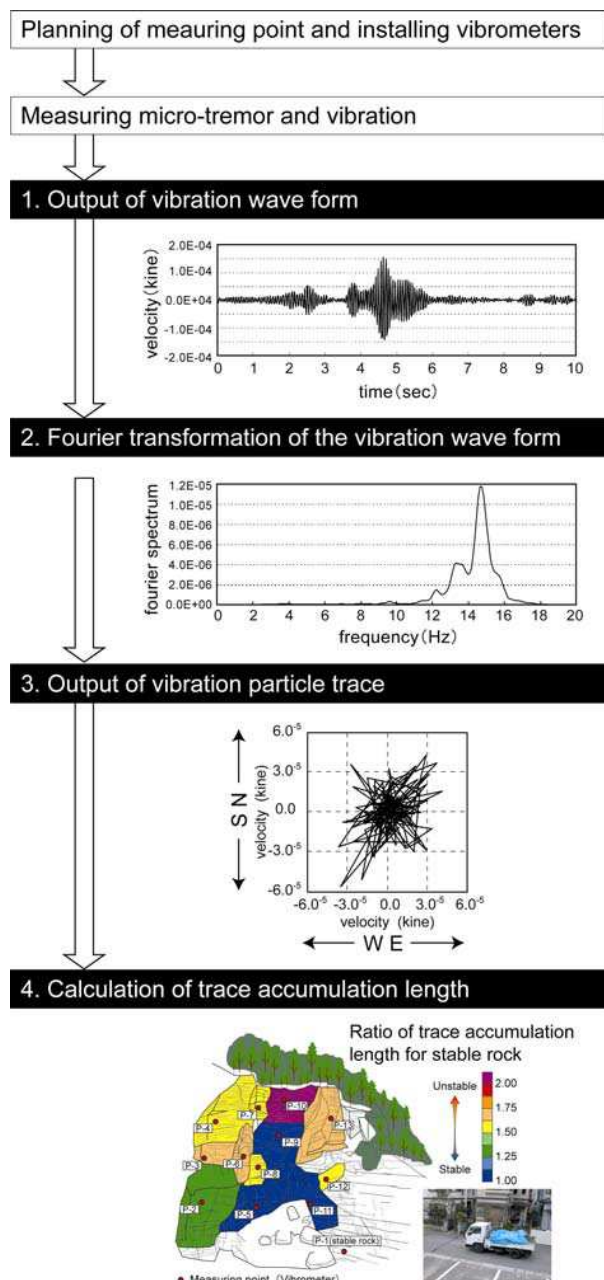
Fig. 4. Flow of analysis.

The vibration that has been measured is analyzed to evaluate the stability of rock blocks as shown in Fig. 4. First, the vibration wave form is output and its amplitude and the way it declines, and other characteristics are visually observed to judge the instability at the measurement point. Secondly, a Fourier transformation of the vibration wave form is performed to obtain the frequency spectrum. The results of the frequency spectrum analysis are applied to judge whether or not measurement points are on the same rock block, based on characteristics such as the existence/non-existence of a dominant frequency, its value, etc. Third, because the vibration is measured in three dimensions, combinations of two dimensions are formed to output the vibration particle trace in a total of three directions: one horizontal direction and two vertical directions. The vibration particle trace visually shows

the amplitude of the vibration, but also permits observation of the direction of the vibration and allows the evaluation of the instability of each measurement point accompanied by a judgment of whether or not they are on the same block. Fourth, trace accumulation length (cumulative length of the trace of the vibration of a measurement point within a fixed period of time) is obtained to represent the vibration amplitude numerically based on the vibration particle trace. This value is used to establish the priority of relative instability of unstable blocks. Trace accumulation length is a new concept applied by this measurement technology, and is a value obtained by accumulating the lengths of traces moved by vibration at the measurement points on rock during a fixed period of time.

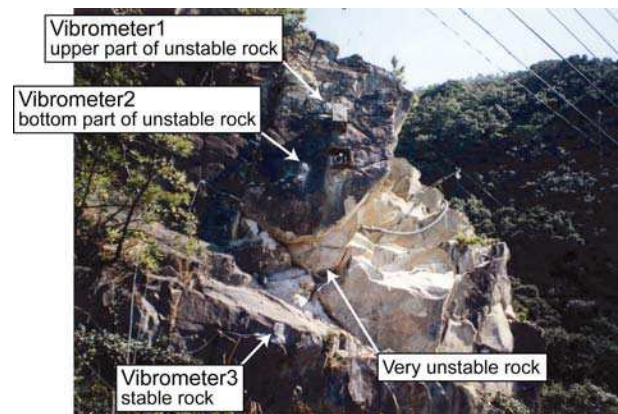
Fig. 5. Situation at Site A.

In Site A where overturning type rock failure had actually occurred, the relationship between the stability and vibration properties of rock blocks was surveyed (Asai et al., 2003, 2005). Figure 5 shows the state of the rock cliff and the layout of the vibrometers. The rock blocks are composed of sandstone that is about 4 m high, 2.5 m wide, and 1 m thick, and there are open cracks on their back surfaces. During the test, the bottom of the rock block was destabilized by crushing or the rock bloc was stabilized by pushing it towards the mountain to artificially vary the stability of the rock block and to measure the rock vibrations under each state. The vibrometers were installed at two locations at the top and bottom of rock block and at one point on stable rock.

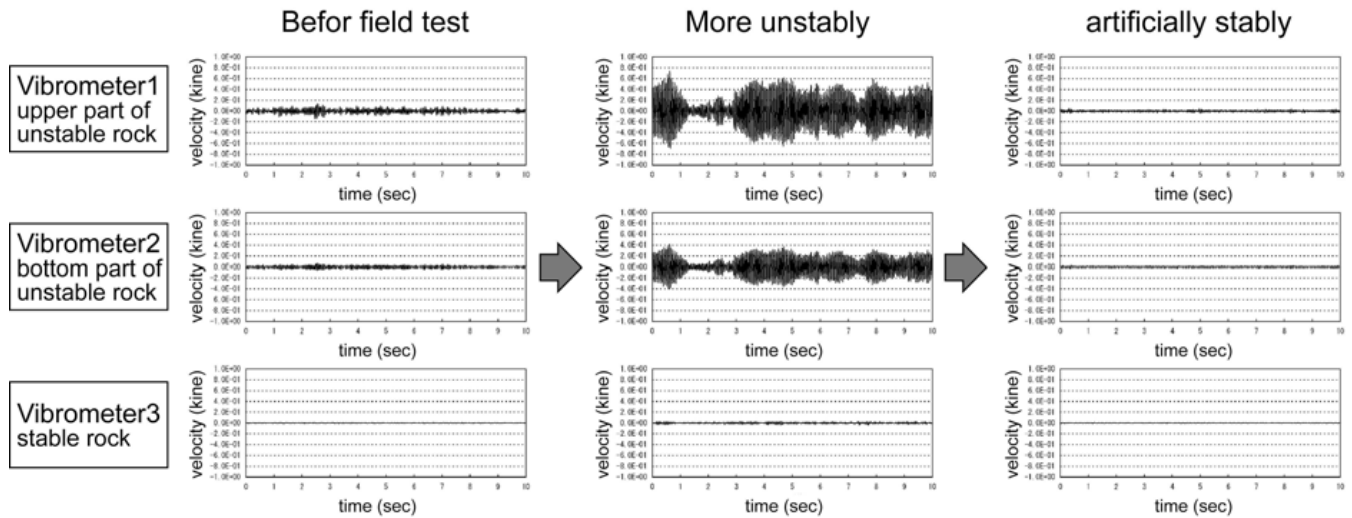
Fig. 6. Relationship between rock stability and vibration.

Figure 6 shows the normal micro-tremors before the rock block was destabilized and when its stability was varied.

When the rock block was destabilized, its vibrations were greater than in its previous state. Later when the rock block was stabilized, its vibrations fell.

This demonstrates there is a correlation between the stability and the vibration properties of the rock block, so that it is possible to evaluate the stability of a rock block by analyzing the state of its vibrations.

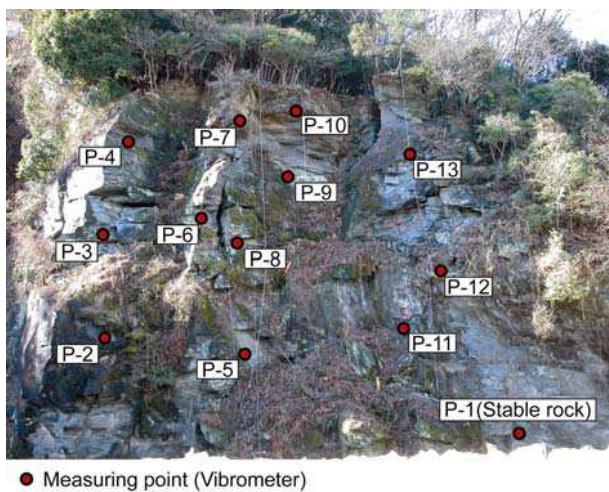
Fig. 7. Situation at Site B.

In Site B, vibration measurements were done in order to identify unstable rock blocks (Asai, 2004). This rock cliff is at risk of rock failure so preventive measures must be taken. The rock cliff that is made of crystalline schist is divided into many blocks by horizontal cracks formed by the joint faces and vertical cracks at right angles to the horizontal cracks. It was hypothesized that it includes many unstable rock blocks. Figure 7 shows the state of rock cliff and the layout of the measurement points. The measurements were done by installing measurement points at a total of 13 locations, including stable rock (P-1) installed on the lower right so that the major rock blocks are encompassed. The measurements were performed to measure normal micro-tremors and vibrations produced by artificial vibrations applied by the passage of a two-ton truck and by an oscillator.

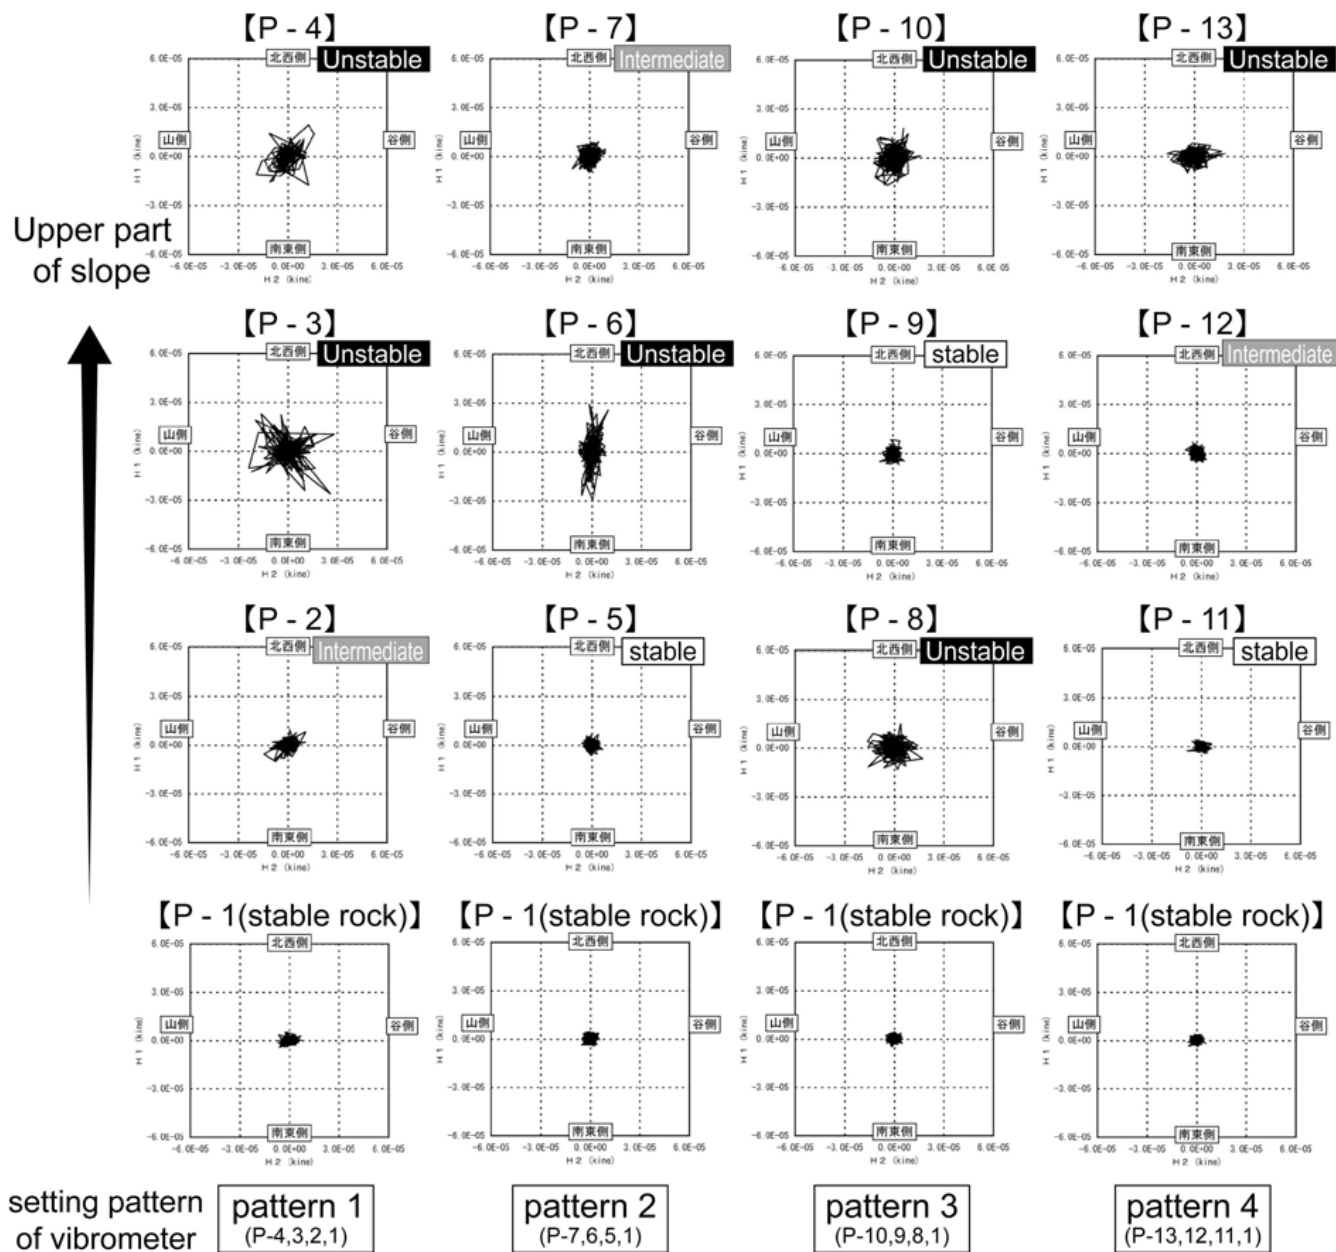
Fig. 8. Results of measuring vibration particle traces.

The results of the measurements when vibrations were applied artificially by the two-ton truck are shown. Figure 8 shows the plane vibration particle trace. And Fig. 9 shows the ratios of the trace accumulation lengths obtained from the vibration particle traces for the other rock blocks with the value for the stable rock block (P-1) as the reference value.

1. P-5, P-9, and P-11 are stable, because the fluctuation of those vibration particle traces are small similarly to that of the stable rock blocks (P-1) (Fig. 8). Also the ratios of trace accumulation length for stable rock are low for those blocks (Fig. 9).
2. P-3, P-4, P-6, P-8, P-10, and P-13 are unstable, because the fluctuation of those vibration particle traces are large compare to that of the stable rock blocks (P-1) (Fig. 8). Also the ratios of trace accumulation length for stable rock are high for those blocks (Fig. 9).

3. P-2, P-7, and P-12 are intermediate state (between stable and unstable), because the fluctuation of those vibration particle traces are likely small as to that of the stable rock blocks (P-1) (Fig. 8), but the ratios of trace accumulation length for stable rock are intermediate for those blocks (Fig. 9).

And if the rock blocks are integrated, the directions of their vibrations are harmonized. Therefore, judging from the dominant vibration direction of the vibration particle trace shown in Fig. 8, at P-3, P-6, and P-8, there were unstable rock blocks separated from the rock blocks above them. A detailed survey of the Site was done, confirming that at P-3, P-6, and P-8, there were clearly opened cracks on the front

and side surfaces, and these were unstable rock blocks completely separated from the foundation.

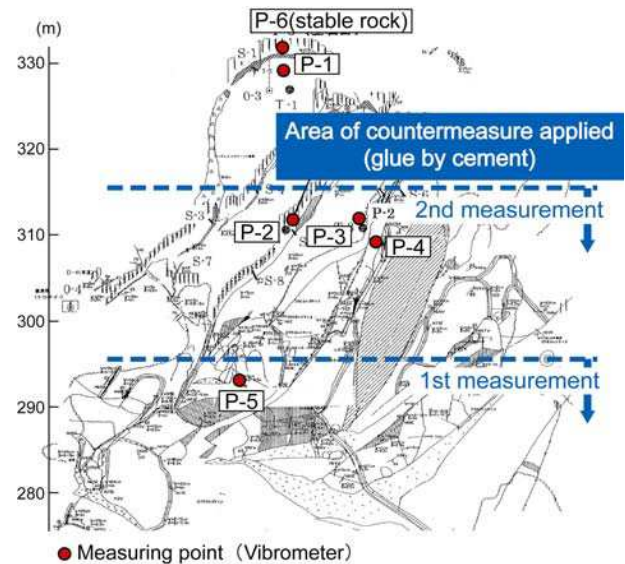
Fig. 10. Situation at Site C.

On a rock cliff in Site C, bonding material was injected into open cracks on the unstable rock block. On this cliff, vibration was measured before and after this was done in an attempt to make a judgment of the effectiveness of this countermeasure by this method (Asai, 2005). Figure 10 shows a sketch of the rock cliff, the state of progress of the countermeasure work, and locations of measurement points (P-1 to P-6). The measurements were performed once when the countermeasure was completed to above P-5 and a second time when it was completed to above P-2.

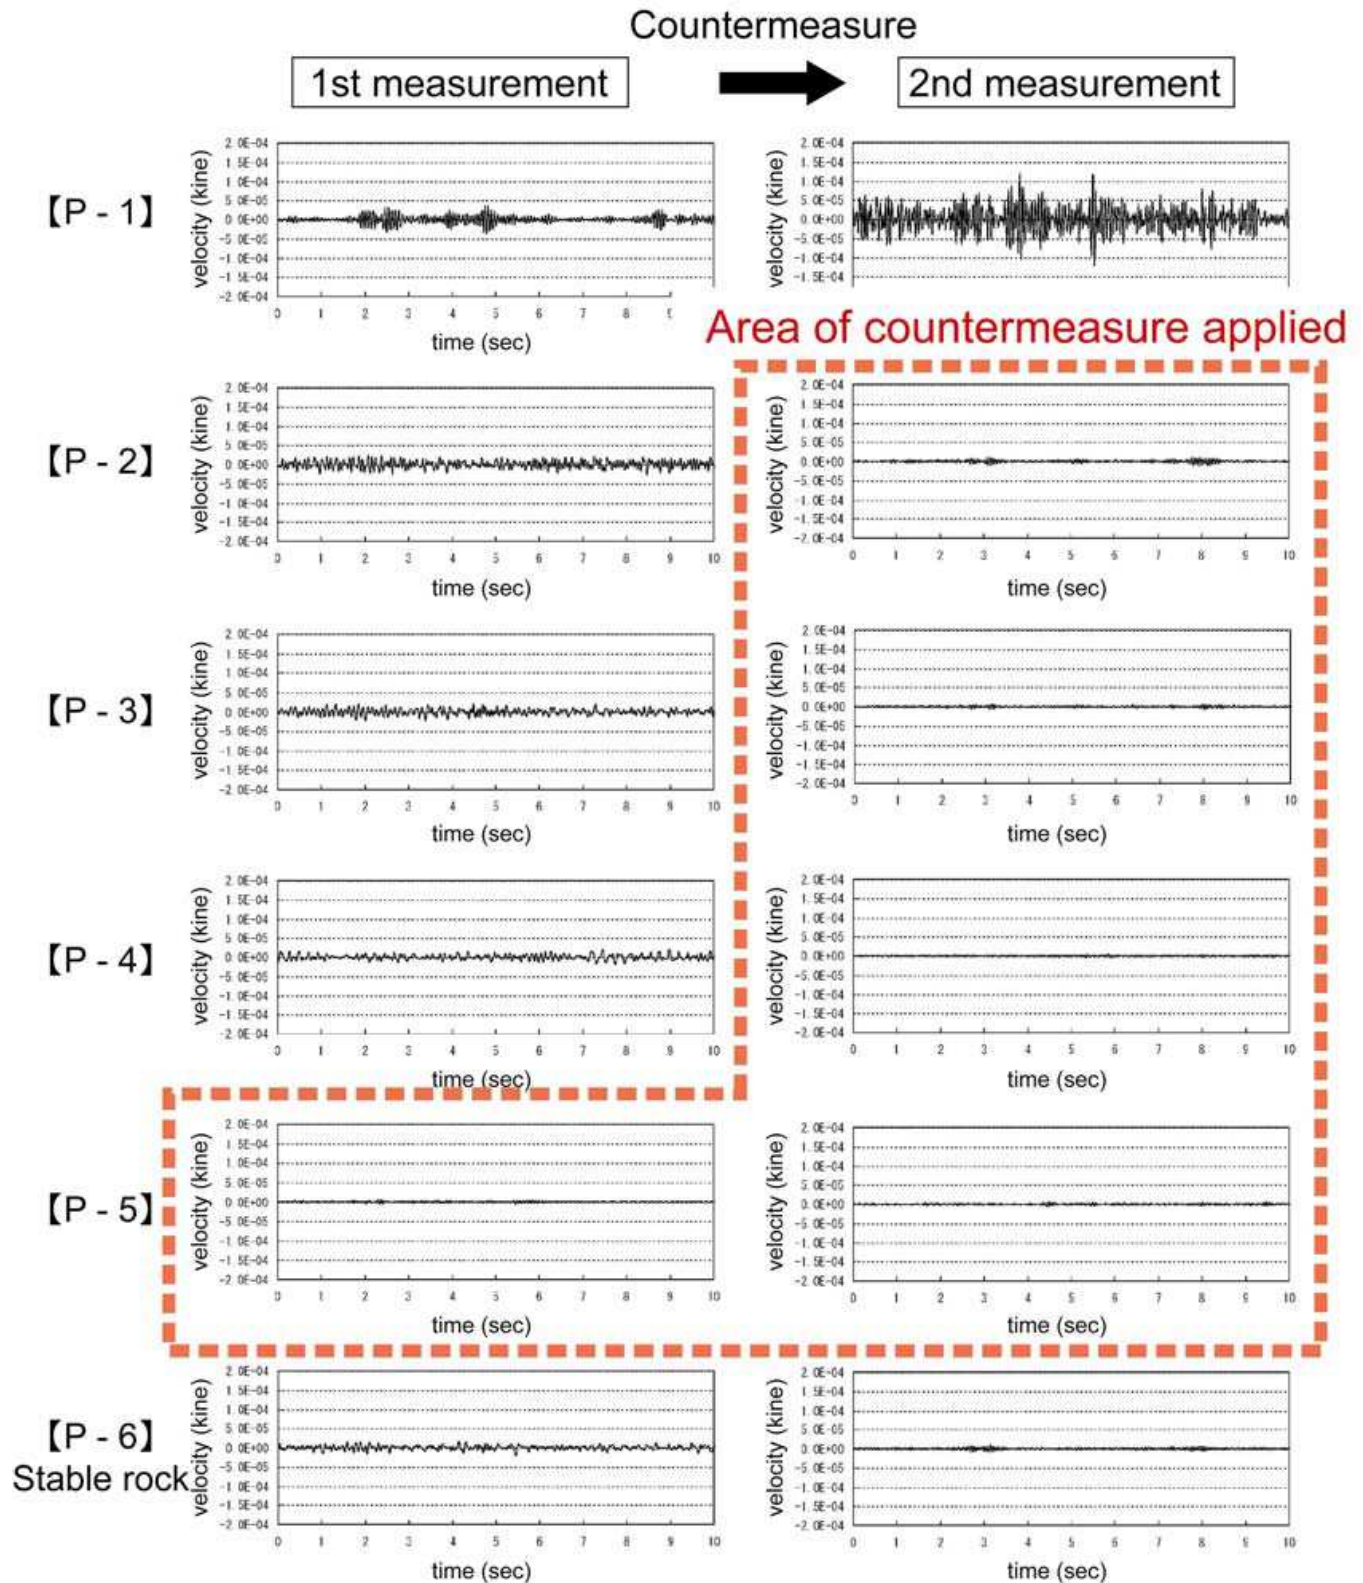
Fig. 11. Vibration wave forms when a countermeasure passed.

Figure 11 shows the wave form when a vehicle passed. The first measurement showed small amplitude at P-5 where the countermeasure was already completed, and the further up the cliff the measurement points – from P-4 to P-1 – the larger the amplitude. In contrast, the second measurement shows that the amplitude at P-2 to P-4 where the countermeasure was newly taken was small as at P-5. But, at P-1 where the measure was not taken, the amplitude continued to be large.

For the above reasons, the fluctuation of the amplitude of rock vibration that was measured is in harmony with the state of progress of the countermeasure, and its effectiveness can be judged by measuring amplitude.
